A STUDY ON FAILURE MODES OF LOCOMOTIVE SUSPENSION COIL SPRING

This paper is discussion about automotive suspension coil springs, their materials characteristic, manufacturing and common failures. An in depth discussion on the parameters influencing the quality of coil springs is also presented.

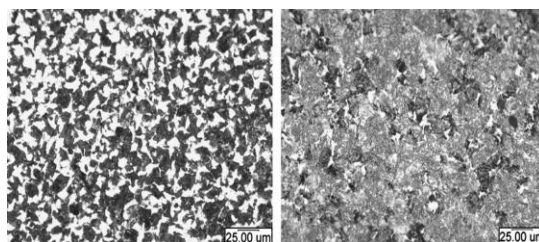
In general, there are two types of foreign materials that can become trapped inside the steel solution: large imperfections such as spinells, and smaller imperfections such as inclusions that are caused by alloying elements. Fig.3 shows a raw material defect that is usually very difficult to find after a coil is formed. This type of defect is easy to detect during the cold drawing process of coil manufacturing preparation. An ideal raw material has the form of ferrite pearlite. However, a raw material can also have local bainite inside the ferrite pearlite matrix. Due to a hardness difference, such raw materials may exhibit internal cracking.

Fig.3. Appearance of different microstructures extracted from the same bar. on the left side, the microstructure is normal ferrite pearlite. on the right side, the same material has bainite structure inside the ferrite pearlite matrix

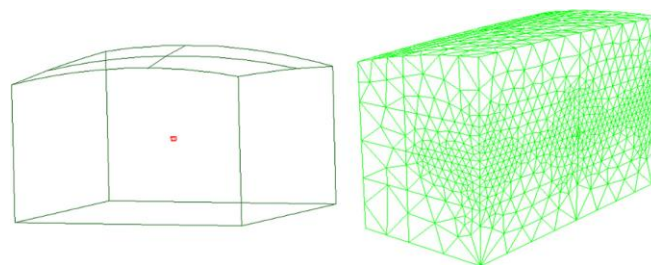
A cubic hole was placed about 1 mm below the outer surface; its size is 50 μm (Fig.9, red dot is the inclusion). Instead of using a foreign material for the cubic area, it was left as a hole for simplification. Since a higher stress concentration was expected around the inclusion area, a finer mesh was used at the center and coarser mesh was used at the outer area (Fig.9b). The stress distribution is shown in Fig.10. As expected, a local stress concentration is observed at the inclusion area, and the highest Von Mises stress reached 2000 MPa, which is higher than the outer surface stress level. Stress on other areas, such as outer surface, was at the same level as the no-defect model.

Fig.9. Part model with inclusion. (Left), FEA model with inclusion (display model is cut in half to show inside) (right)

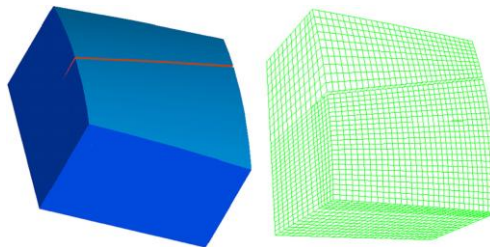
A model was created based on a crack on outer surface of spring, the surface imperfection is inherited from the raw material. A crack (50 μm width, 500 μm depth) alongside of the centerline of the wire was applied to the Submodel 2 as shown in Fig.11. The stress distribution is shown in Fig.12. A high stress concentration is observed at the crack location, and the Von Mises stress exceeded 4000 MPa, which is much higher than the outer surface stress level. Therefore, the product would likely fail from this point. A stress concentration is also observed at the vertical edge, however this concentration occurred due to the boundary condition and should be ignored.

Fig.11. Part model with imperfection (Left) and its FEA model (right)

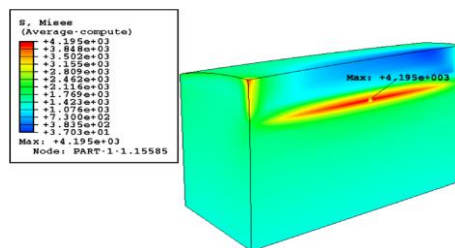
Fig.12. Von Mises Stress result of imperfection model (display model was cut at crack location)

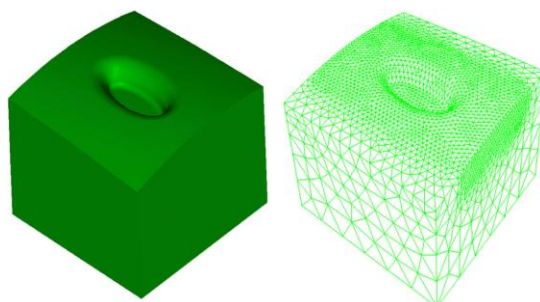
Instead of modeling the actual corrosion part, a simple oval shape was removed from the outer surface to simplify the FEM model. Its size is approximately 300 μm in depth, 500 μm in height, and 1mm in width. Finer meshing was used around the corrosion area since a higher stress concentration was expected there. The model is shown in Fig.13. The stress distribution is shown in Fig.14. As expected, a local stress concentration is observed at the

Fig.13. Part model with corrosion (left) and its FEA model (right)
