A STUDY ON FAILURE MODES OF LOCOMOTIVE SUSPENSION COIL SPRING

Manish Dakhore¹, Bhushan Bissa², Deepak Hajare³ and Rahul Waghmare⁴

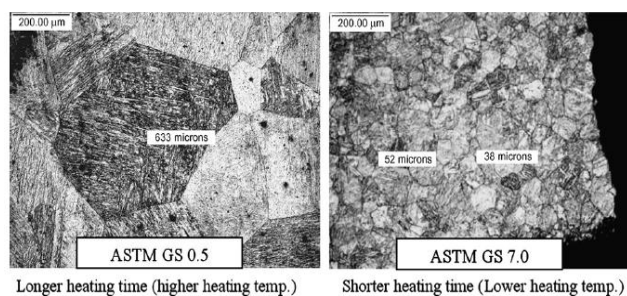
Fig. 2. Identical raw materials heated with different heating patterns. on the left, the prior austenite grain size is clearly larger than that of the right.

Improper heat treatment can be easily overlooked since a temperature difference in heating does not relate directly to the hardness of the material. Extensive evaluations are usually needed to identify this problem. Fig.2 shows a typical example of an improper heat treatment. Prolonged heating can cause the prior austenite grain size to grow significantly. Improper heat treatment can also result in the microstructure becoming pearlite instead of the required martensite. This type of defect is easier to identify due to the clear difference in hardness. Fig.5 shows two different coils of the same product with varying microstructure. This defect usually occurs when the heating system does not operate normally. Again, referring to the figure, the left hand side coil has a much lower lifetime than that of the right side. Tempering induces the decomposition of the retained austenite into mixture of ferrite and carbides

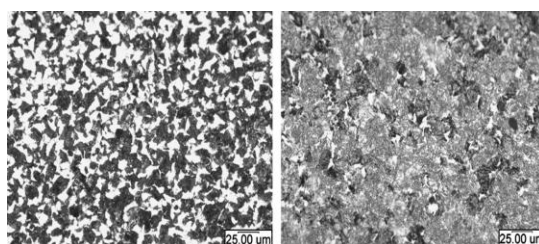
In general, there are two types of foreign materials that can become trapped inside the steel solution: large imperfections such as spinells, and smaller imperfections such as inclusions that are caused by alloying elements. Fig.3 shows a raw material defect that is usually very difficult to find after a coil is formed. This type of defect is easy to detect during the cold drawing process of coil manufacturing preparation. An ideal raw material has the form of ferrite pearlite. However, a raw material can also have local bainite inside the ferrite pearlite matrix. Due to a hardness difference, such raw materials may exhibit internal cracking.

Fig.3. Appearance of different microstructures extracted from the same bar. on the left side, the microstructure is normal ferrite pearlite. on the right side, the same material has bainite structure inside the ferrite pearlite matrix

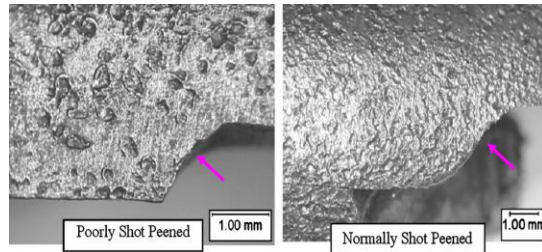
Surface imperfections can occur as small hardening cracks, tool marks, scale embedded to the base material during cold drawing, or surface flaws inherited by the raw material. Poorly shot peened surfaces can also be classified as surface imperfections. Fig.4 shows a comparison between two different coils that failed at similar locations, but possessed completely different fatigue lives. On the left side, the surface was shot peened poorly and therefore exhibited a shorter life. On the right side, the surface was shot peened sufficiently and therefore had a longer life. An example of a small quench crack that can be classified as a surface imperfection In this case the heating process and the heat treatment itself were not wrong, however, the quench oil was contaminated with water, causing an extremely high

Fig.4. Surface imperfections due to poor shot peening condition

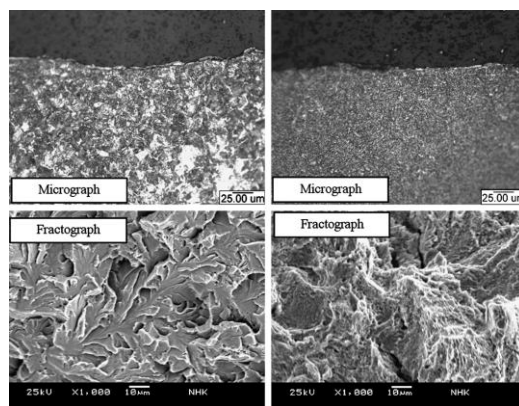
Fig.5. Improperly heat treated sample (left) vs. properly heat treated sample (right).

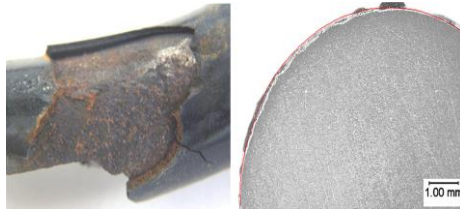
Corrosion is a more common cause of spring breakage than is usually understood by users; however, recent coating technology has reached a point where it is able to protect the metal from even the hardest cold stone chipping. Fig.6 shows the appearance of a coil which failed due to corrosion. The right side of the figure depicts the cross section of the corresponding coil, with the 1 line illustrating its approximate original dimension.

Fig.6. Coil spring which broke due to corrosion

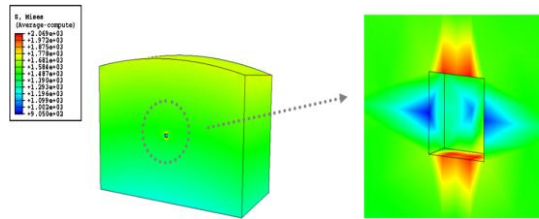
A cubic hole was placed about 1 mm below the outer surface; its size is 50 μm (Fig.9, red dot is the inclusion). Instead of using a foreign material for the cubic area, it was left as a hole for simplification. Since a higher stress concentration was expected around the inclusion area, a finer mesh was used at the center and coarser mesh was used at the outer area (Fig.9b). The stress distribution is shown in Fig.10. As expected, a local stress concentration is observed at the inclusion area, and the highest Von Mises stress reached 2000 MPa, which is higher than the outer surface stress level. Stress on other areas, such as outer surface, was at the same level as the no-defect model.

Fig.10. Von Mises stress result of inclusion model.

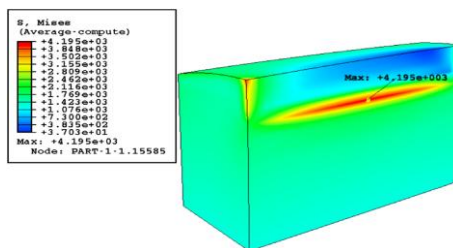
A model was created based on a crack on outer surface of spring, the surface imperfection is inherited from the raw material. A crack (50 μm width, 500 μm depth) alongside of the centerline of the wire was applied to the Submodel 2 as shown in Fig.11. The stress distribution is shown in Fig.12. A high stress concentration is observed at the crack location, and the Von Mises stress exceeded 4000 MPa, which is much higher than the outer surface stress level. Therefore, the product would likely fail from this point. A stress concentration is also observed at the vertical edge, however this concentration occurred due to the boundary condition and should be ignored.

Fig.12. Von Mises Stress result of imperfection model (display model was cut at crack location)

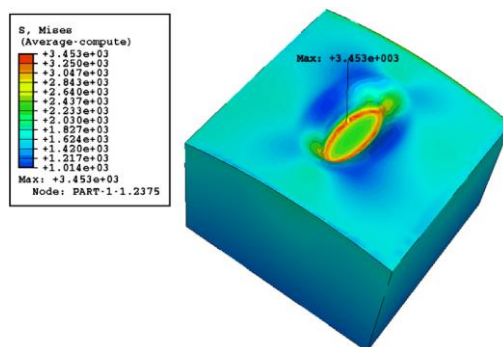
Instead of modeling the actual corrosion part, a simple oval shape was removed from the outer surface to simplify the FEM model. Its size is approximately 300 μm in depth, 500 μm in height, and 1mm in width. Finer meshing was used around the corrosion area since a higher stress concentration was expected there. The model is shown in Fig.13. The stress distribution is shown in Fig.14. As expected, a local stress concentration is observed at the

bottom edge of the corrosion area, and its Von Mises was about 3450 MPa, which is again much higher than the outer surface stress level. This high stress concentration will cause early spring breakage from this point.

Fig.14. Von Mises stress result of corrosion model
