A STUDY ON FAILURE MODES OF LOCOMOTIVE SUSPENSION COIL SPRING

This paper is discussion about automotive suspension coil springs, their materials characteristic, manufacturing and common failures. An in depth discussion on the parameters influencing the quality of coil springs is also presented.

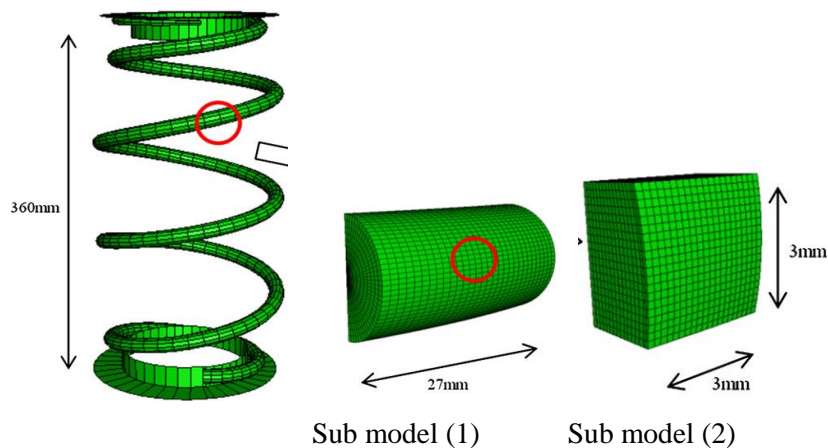
Fig.7. FEA model of a coil spring and its sub models

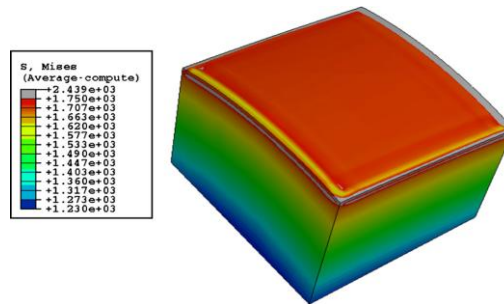
Fig.8. Von Mises stress result of no-defect model

For comparison with the defect model, Sub model 2 was analyzed first without any defects. Boundary conditions were interpolated from the result of Sub model 1 to the inner and side surfaces of Sub model 2. Fig.8 shows the Von Mises stress distribution. The highest stress was found at the outer surface and the lowest at inner side of wire. The highest Von Mises stress was about 1715 MPa, which matches the stress level of the global model. The gray area around the outer edge shows a stress concentration, however this is ignored since it is where the boundary condition was applied.
