A STUDY ON FAILURE MODES OF LOCOMOTIVE SUSPENSION COIL SPRING

Manish Dakhore¹, Bhushan Bissa², Deepak Hajare³ and Rahul Waghmare⁴

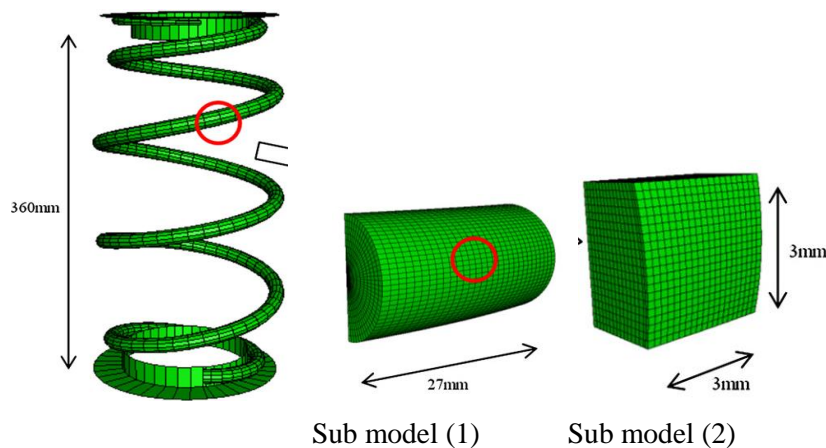
A finite element analysis was performed to check the local stress distribution around a given defect using a typical coil spring. First, the overall stress distribution was checked without any defect in the material, and then at the location where the highest stress was found, each defect was added. Since the size of the defect is significantly smaller than the whole model, a sub modeling technique [4] was used. This technique is used to study a local part of a model with refined meshing based on the FEA result of a global model with coarse meshing. Boundary conditions for the sub model will be automatically interpolated from the global model solution. As shown in Fig.7, the sub modeling technique was used twice for this study. Sub model 2 was modified to apply various defects. For meshing, either the quadratic brick element (C3D20) or quadratic tetrahedron (C3D10) was used. For material specifications, typical spring steel properties, $E = 210$ GPa and $\nu = 0.3$, were used except for the decarburized layer. The commercially available FEA software, ANSYS, was used here to study each stress distribution.

Fig.7. FEA model of a coil spring and its sub models

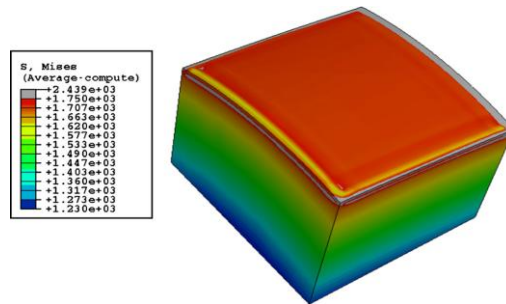
Fig.8. Von Mises stress result of no-defect model

For comparison with the defect model, Sub model 2 was analyzed first without any defects. Boundary conditions were interpolated from the result of Sub model 1 to the inner and side surfaces of Sub model 2. Fig.8 shows the Von Mises stress distribution. The highest stress was found at the outer surface and the lowest at inner side of wire. The highest Von Mises stress was about 1715 MPa, which matches the stress level of the global model. The gray area around the outer edge shows a stress concentration, however this is ignored since it is where the boundary condition was applied.

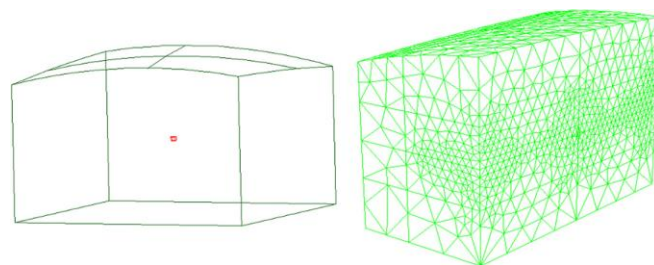
A cubic hole was placed about 1 mm below the outer surface; its size is 50 μm (Fig.9, red dot is the inclusion). Instead of using a foreign material for the cubic area, it was left as a hole for simplification. Since a higher stress concentration was expected around the inclusion area, a finer mesh was used at the center and coarser mesh was used at the outer area (Fig.9b). The stress distribution is shown in Fig.10. As expected, a local stress concentration is observed at the inclusion area, and the highest Von Mises stress reached 2000 MPa, which is higher than the outer surface stress level. Stress on other areas, such as outer surface, was at the same level as the no-defect model.

Fig.9. Part model with inclusion. (Left), FEA model with inclusion (display model is cut in half to show inside) (right)
